Masonry flashing must make sure that water travels to the exterior at all locations...We must review all entry points back into the building.

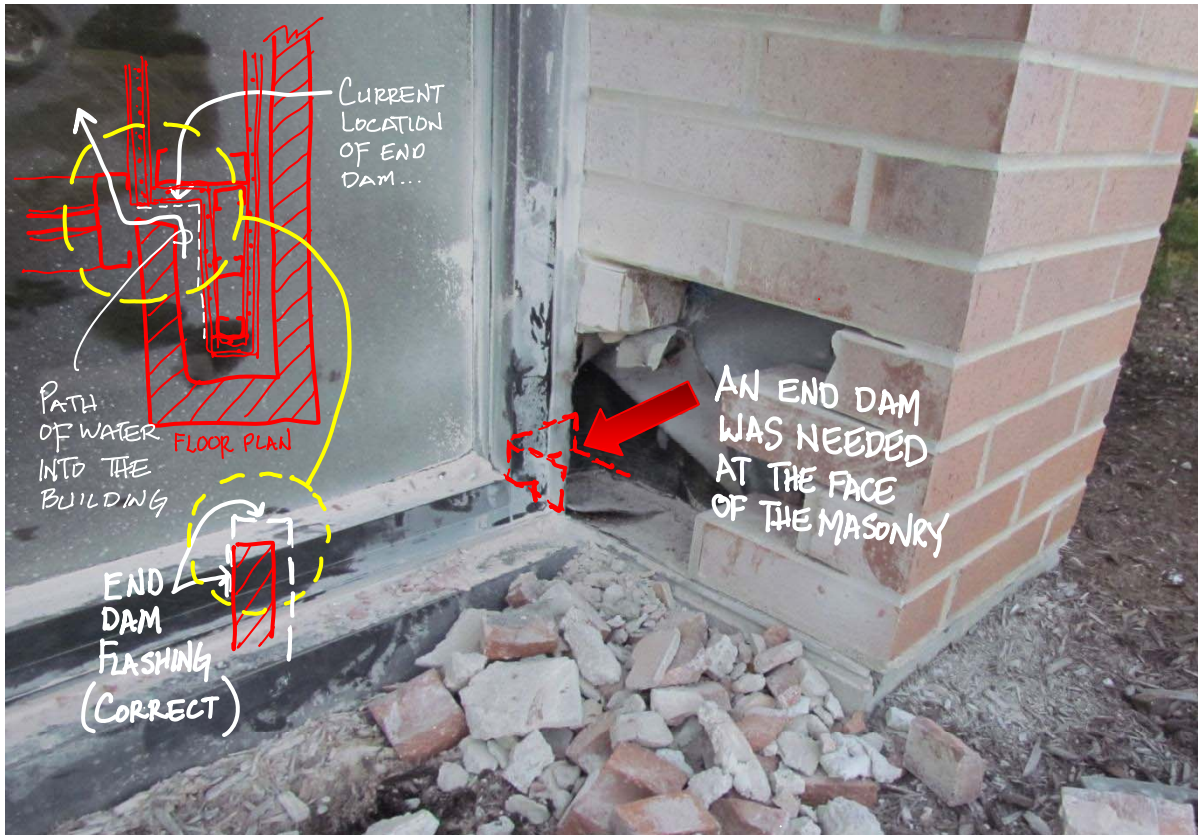
WATER WILL GET INTO THE SYSTEM THROUGH THE MORTAR JOINTS & FAILED SEALANT (OVER TIME)

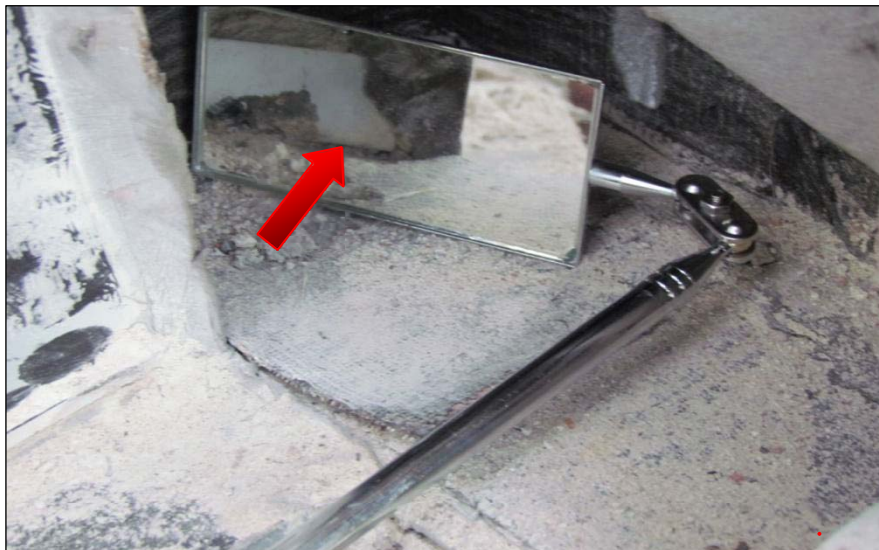
WATER WAS ABLE TO GET IN-BETWEEN THE WINDOW END DAM & THE MASONRY

The End dam was located only at the end of the masonry run...and not on the side of the window unit.

This is a common mistake that is frequently overlooked.
