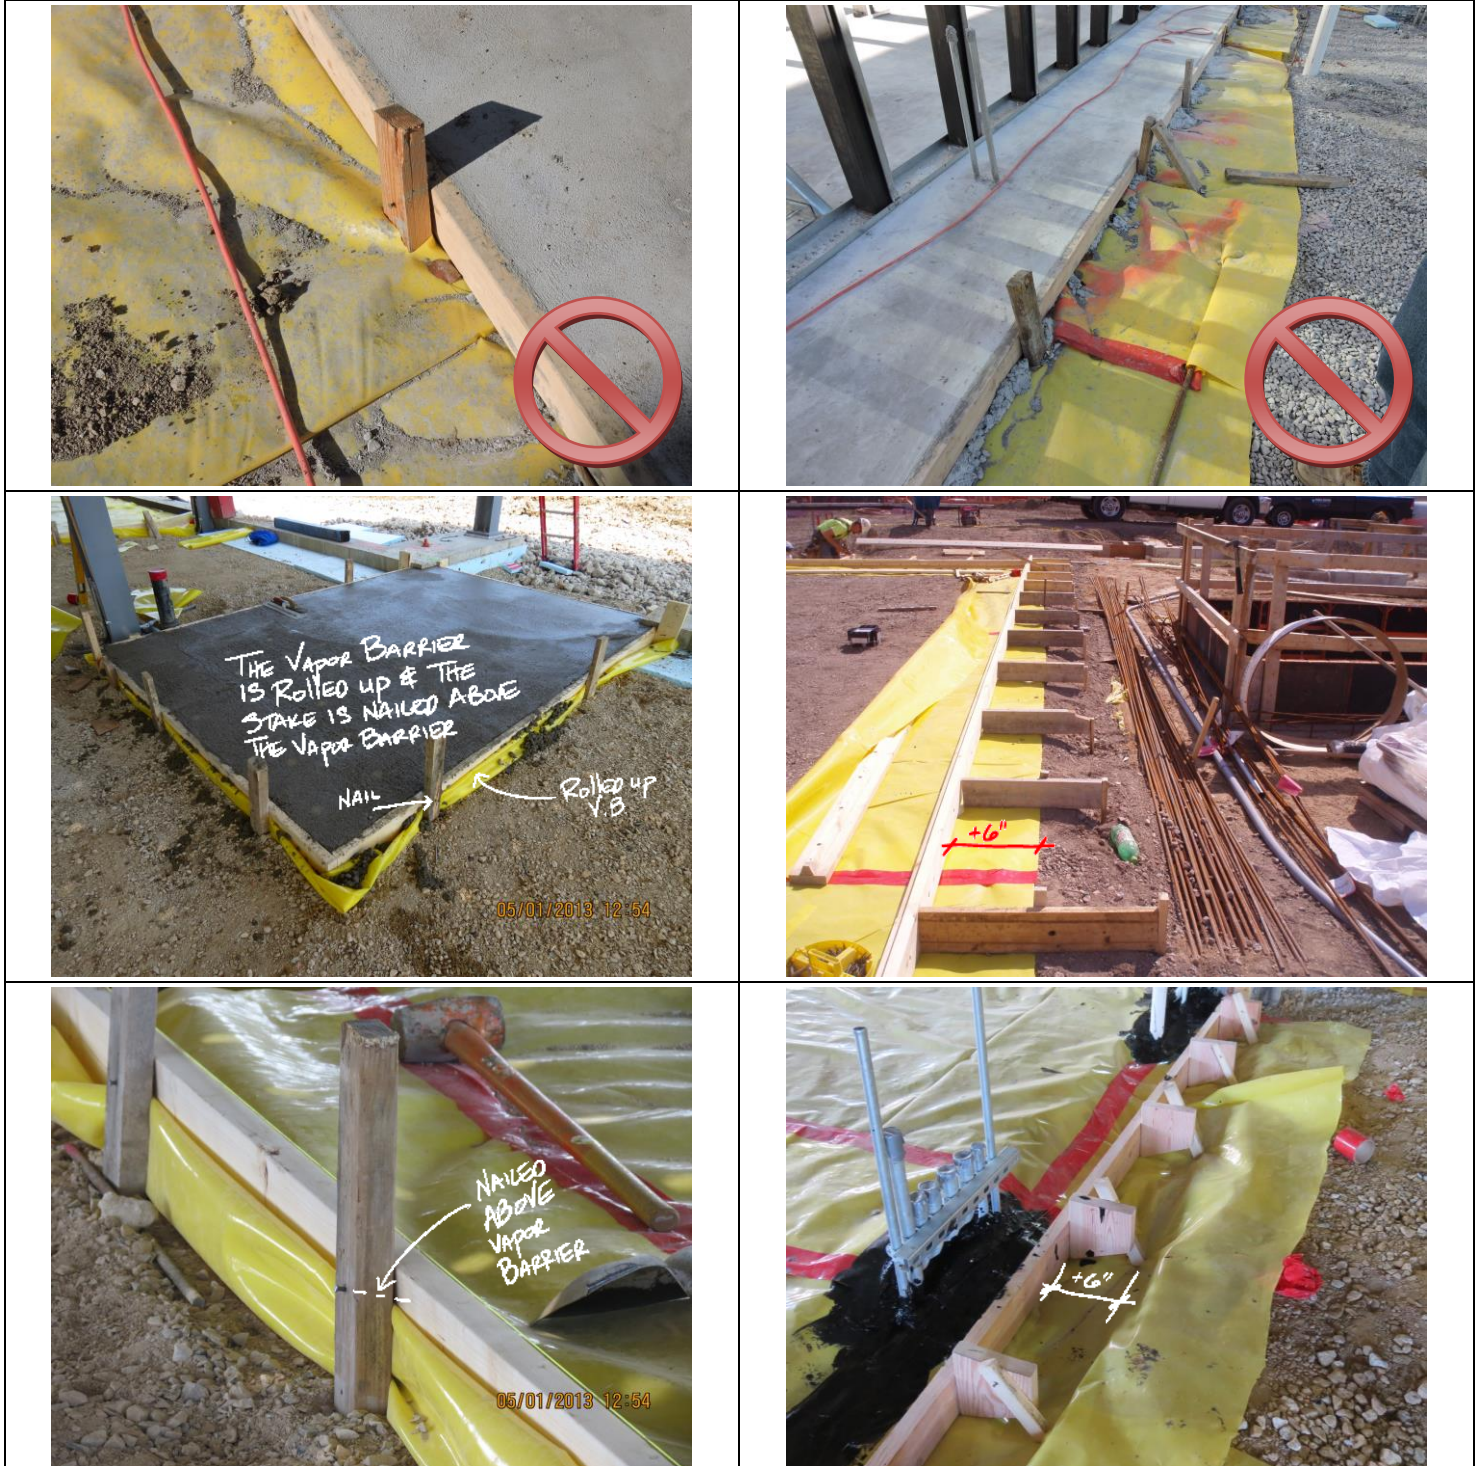
Slab on grade vapor barrier must have a proper overlap to correct penetrations...we are unable to correct the vapor barrier when the wood stake is directly adjacent the construction joint or slab box-out.

We need to make sure that we have at least 6" of material before the stake installation...and there are several ways to accomplish this:
