When mitigating concrete floors with fiber, an extra step of burning the fiber is necessary in order to prevent moisture failure in the slab.

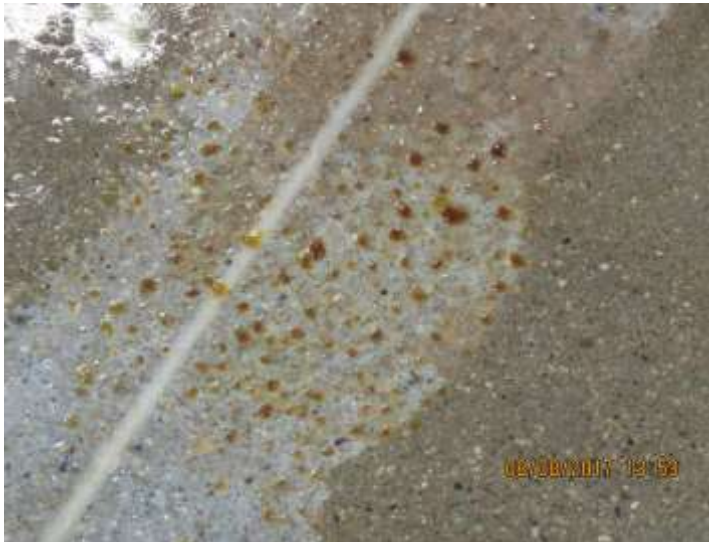
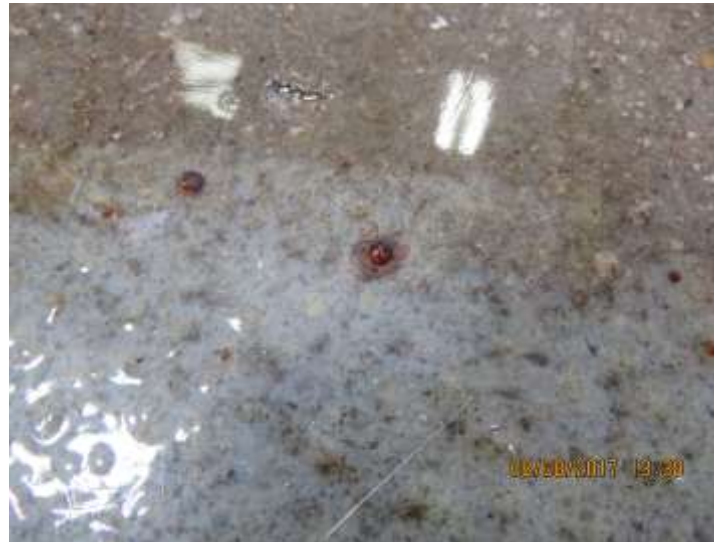
The photos above are of a moisture failure due to the concrete fibers not being properly covered/coated with moisture reduction barrier (MRB). The failure happened within days after installation of the MRB. The floor was not properly burned prior to the installation. The floor required 100% grinding of the MRB, shot blasting, & fiber burning at a cost of over \$80,000

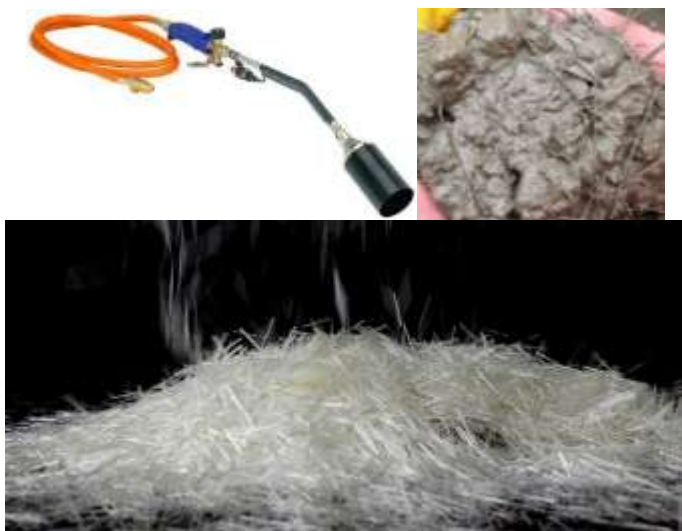
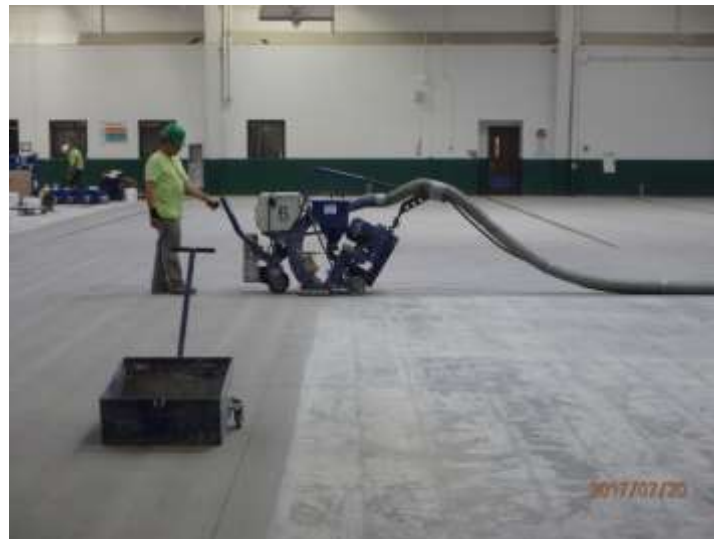
When the fiber is not burned off the surface, the fiber will stick up above the concrete surface and wick the moisture from the slab.

The added cost to shot blast and burn the floor might outweigh the benefit of using fiber. Talk to your flooring contractor.
