When mitigating concrete floors with fiber, an extra step of burning the fiber is necessary in order to prevent moisture failure in the slab.

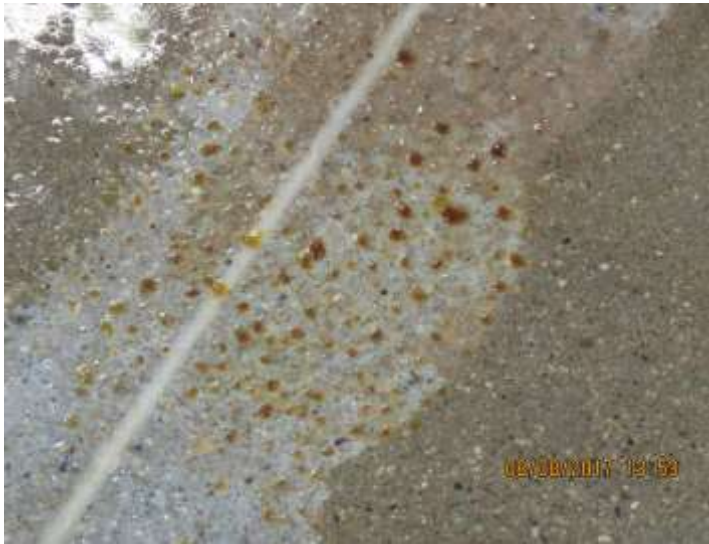
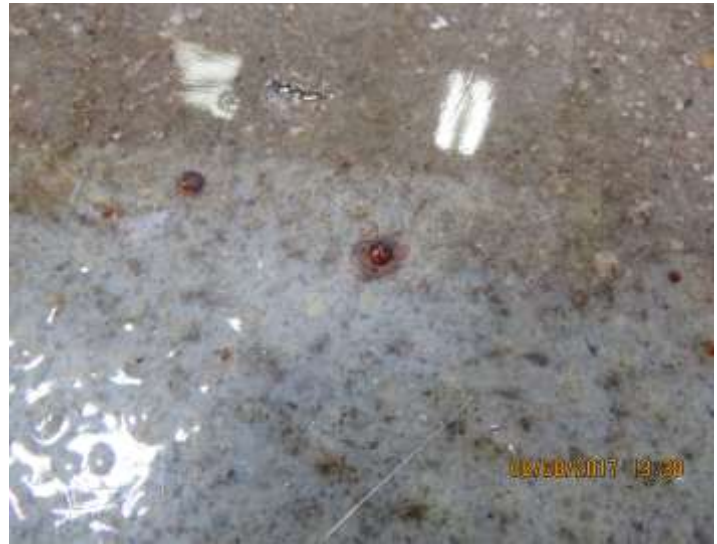
The photos above are of a moisture failure due to the concrete fibers not being properly covered/coated with moisture reduction barrier (MRB). The failure happened within days after installation of the MRB. The floor was not properly burned prior to the installation. The floor required 100% grinding of the MRB, shot blasting, & fiber burning at a cost of over \$80,000

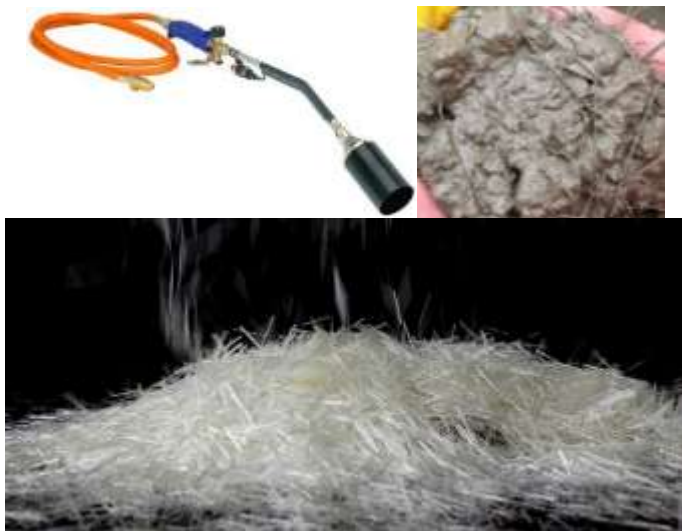
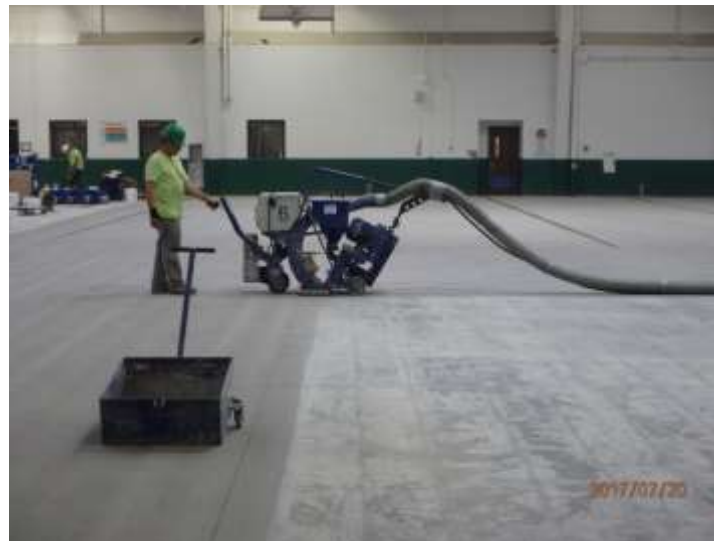
When the fiber is not burned off the surface, the fiber will stick up above the concrete surface and wick the moisture from the slab.

Be careful when substituting wire welded fabric (WWF) for fiber in a concrete slab when it will likely be mitigated due to moisture in the slab.

The added cost to shot blast and burn the floor might outweigh the benefit of using fiber. Talk to your flooring contractor.
