A vapor barrier could either be a part of the building envelope or pipe wrapping and is a key element to reduce the chance of mold either with-in the wall or under the pipe insulation.

**This will be an issue on all jobs, and throughout the entire construction process and needs to be reviewed & corrected several times through-out the process.**

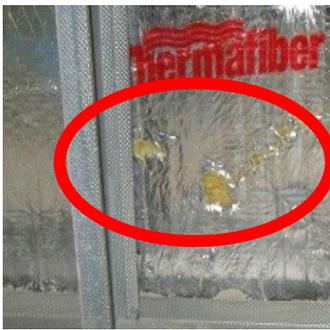
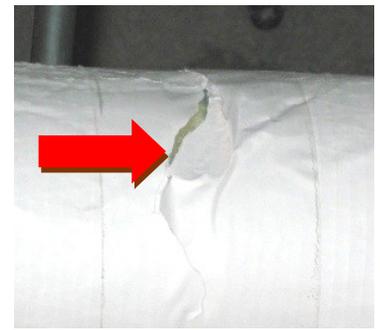
1. Tears in building envelope vapor barrier during/after installation.
2. Tears in the pipe insulation/vapor barrier during/after installation.
3. Pipes in direct contact with another metal (dissimilar) with no insulation or vapor barrier.
4. Compressed pipe insulation = reduced R-value and modification to the dew-point location towards the pipe.

1. Review vapor barrier installation once the installation is complete. Make sure all the joints are properly taped and any holes sealed.
2. Notify all trades that, as they work around newly installed vapor barrier, they need to be careful and make sure Pepper's superintendent is aware of ANY damage noticed or caused during their work.
3. Mark any vapor barrier breaches in green or red in order for future identification prior to any ceiling or wall installation.
4. Review the vapor barrier installation one more times after secondary trades have been in the area and **prior** to any ceiling or wall installation.

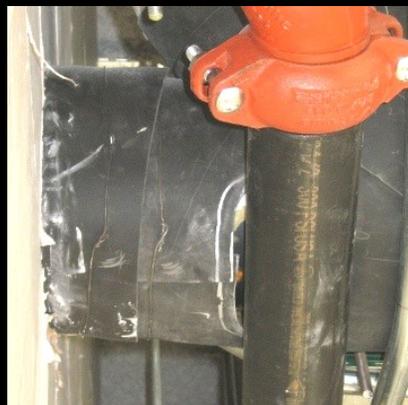
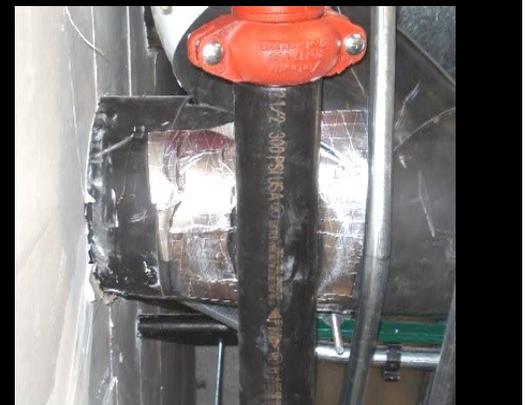
Sometimes, things just get in the way and are cut out by one trade with no regard for another.

The vapor barrier integrity is critical from keeping water from dripping on ceiling tile and supporting the creation of mold.
