Corey Zussman, AIA, NCARB - Director of Quality Management

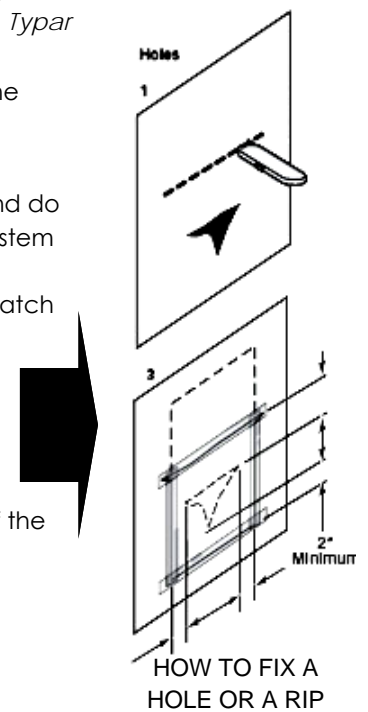
Signs of an Air Barrier issue. Dirty drywall or wood in the cavity.
