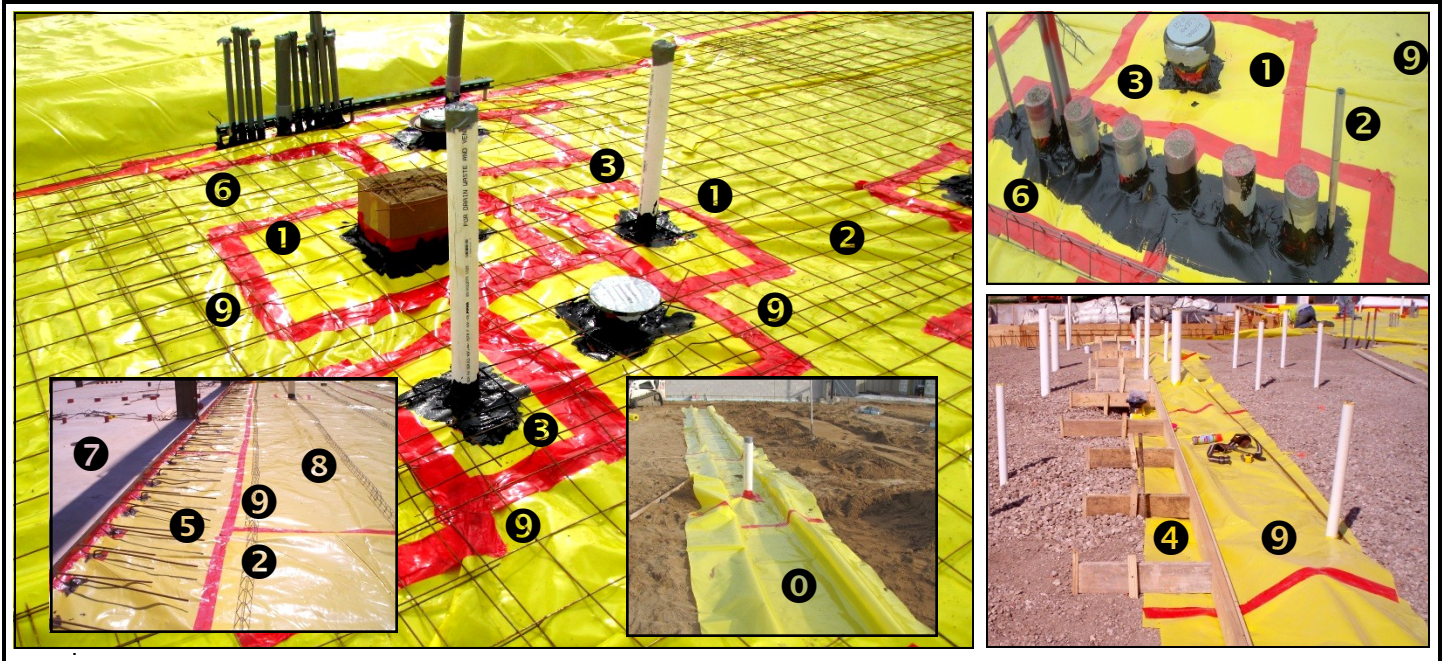
- 0 Vapor barrier has been installed UNDER a future trench drain for complete vapor barrier coverage/protection.
- 1 Proper installation of 18"x18" penetration overlay at each penetration.

- 2 Proper installation of vapor barrier tape—cleaned area with rag prior to tape installation.
- 3 Proper installation of vapor barrier mastic around and up pipe penetration, making sure it is not above the floor line.

- 4 Forms are properly held back at least 9"-12" in order to allow for proper 6" overlap of vapor barrier.
- 5 A 4'-0" vapor barrier edge has been installed to ease field installation.

- 6 Proper installation of vapor barrier mastic around pipe penetration in a group...this is where tape would not work well.
- 7 Edge of slab is properly taped off and properly closes off the vapor barrier at the edge.

- 8 Wire Welded Fabric (WWF) chairs or concrete bricks are properly being installed in order to maintain proper location in the slab.
- 9 Vapor Barrier tape and vapor barrier is installed with NO "fish mouths" or openings on the edges of the tape.

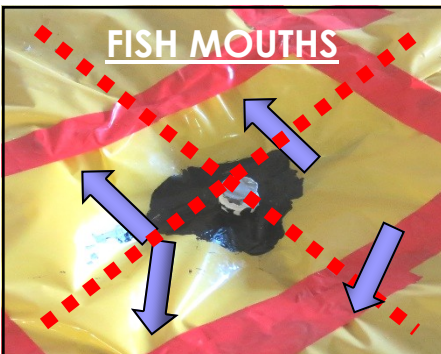
Poor Installation
