The installation of exterior sheathing is critical; many contractors rely on the proper installation of the sheathing for their installations.

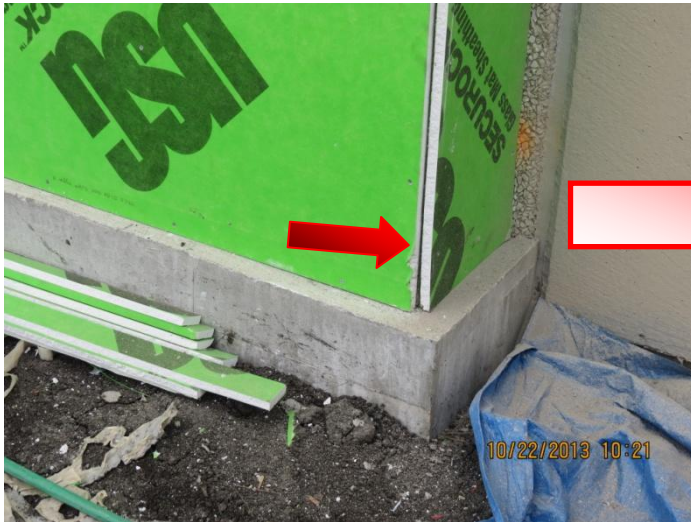
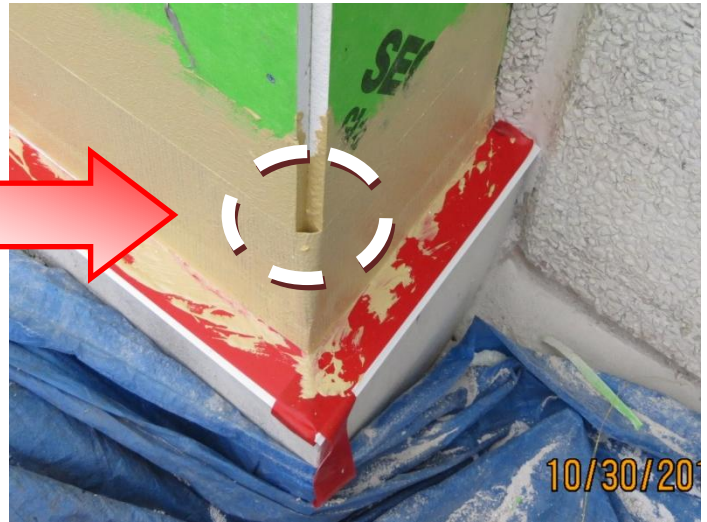
Make sure that corners are square & overlap.  
There should NOT be a gap.  
*AVB must always be supported...*  
*(and sheathing should never rest on the concrete)*

This is a photo of the AVB installation at the corner (photo to the left)...  
As you could see, there is a gap in the AVB due to the sheathing installation.

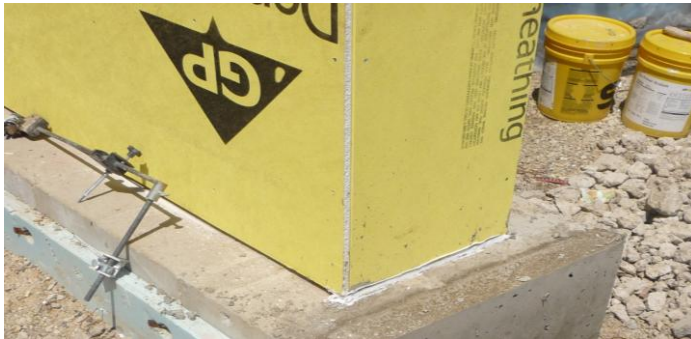
Nice Installation of the sheathing corner

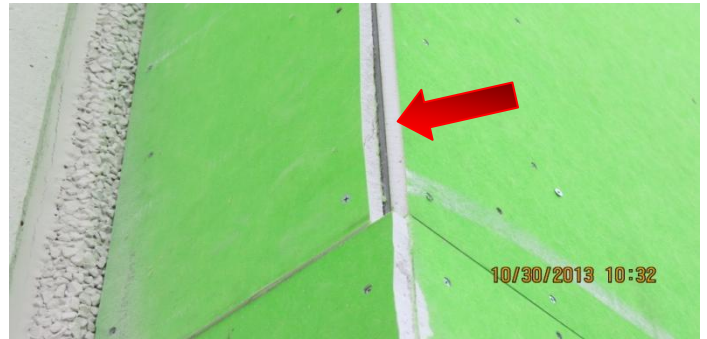
Poor Installation of the sheathing corner

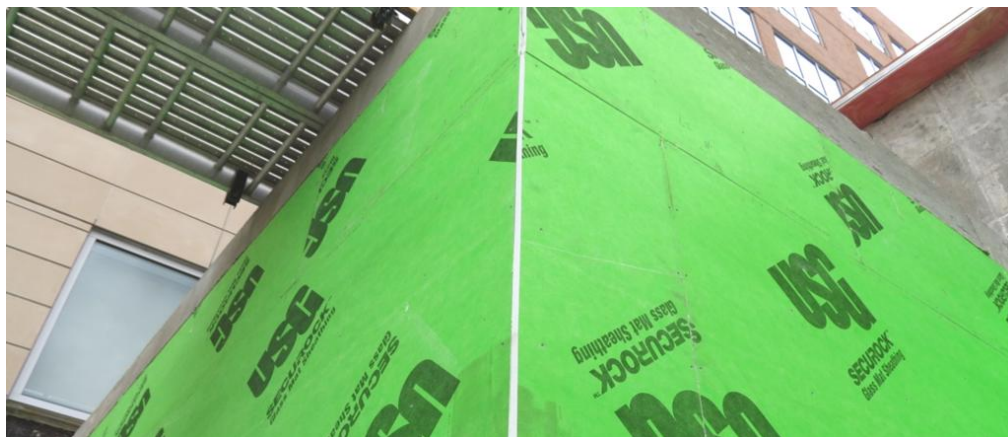
This is a good example of a sheathing corner. The two pieces overlap at the corner and will allow for a proper AVB installation.
