The roof access door...typically a problem when it comes to keeping water out of the building. Dealing with the roofing membrane, which typically is not sealed by sealant well, and the requirement to maintain a continuation of the wall air/vapor barrier and the roof air/vapor barrier, is difficult to coordinate; and note that many of the materials are not compatible with each other. How we deal with all these concerns will determine how well we are able to keep the water out of the building at these locations. I have come up with the following **suggestion** to have the **Architect review and incorporate in their Construction Documents**. Please contact me with any questions or possible improvements.

The attached detail should act as a starting point for a conversation with your entire project team in the early stages of design or soon after award.

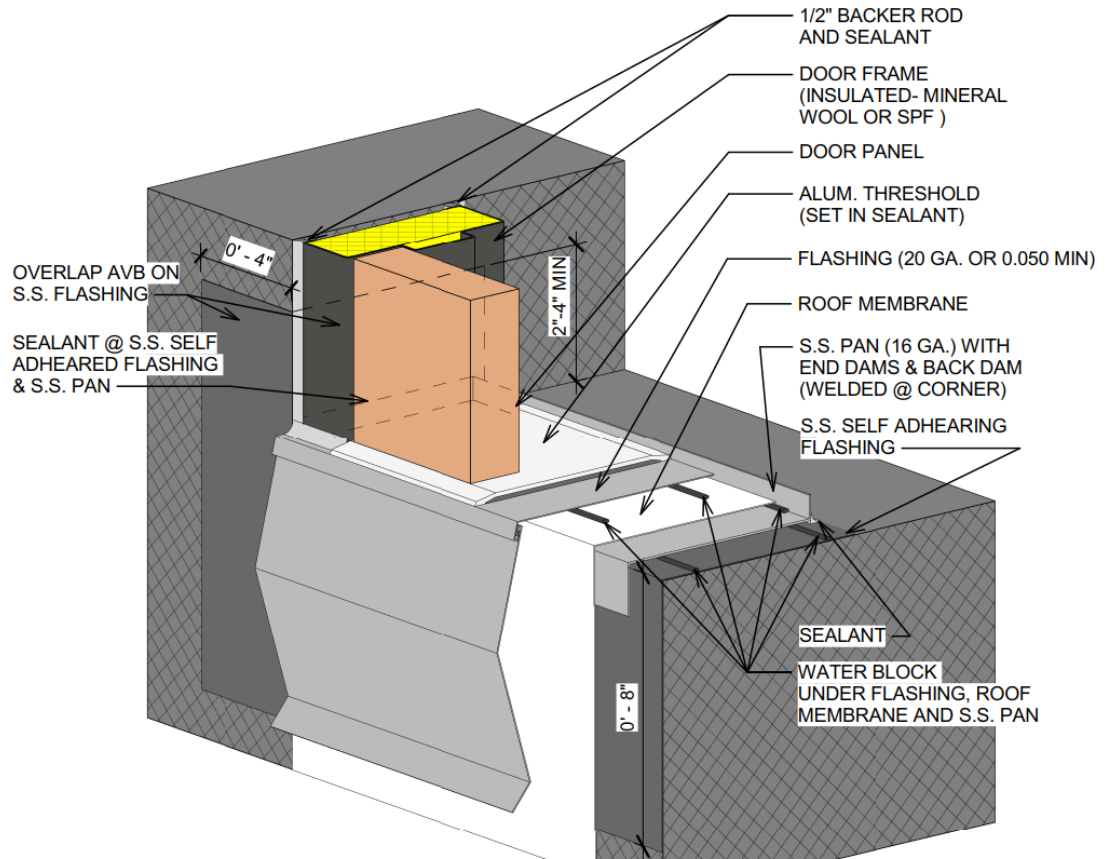
- Typically, the Architectural Construction Documents do not detail the roof access door flashing, air/vapor barrier, and roof air/vapor barrier continuation.
- The stainless steel tape acts as a neutral material connecting the air/vapor barrier and the roofing without compatibility concerns.
- The stainless steel pan acts as a water dam in case water does enter the system.
- Having the metal counter flashing will allow for easier re-roofing without damaging the air/vapor barrier connection.
