A vapor barrier could either be a part of the building envelope or pipe wrapping and is a key element to reduce the chance of mold either with-in the wall or under the pipe insulation.

**This will be an issue on all jobs, and throughout the entire construction process and needs to be reviewed & corrected several times through-out the process.**

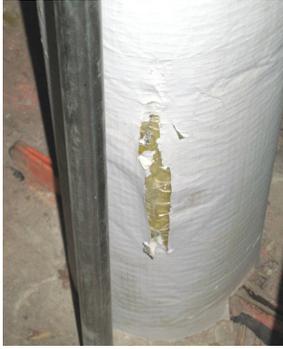
Frequently, the pipe vapor barrier will be installed prior to any other construction activity in the area. The vapor barrier will be installed properly and fully sealed, however, damage will occur to the vapor barrier due to another trade, such as a carpenter, electrician, plumber, etc., or something will be in the way and compress the insulation, or just simply get nicked during another trades installation.

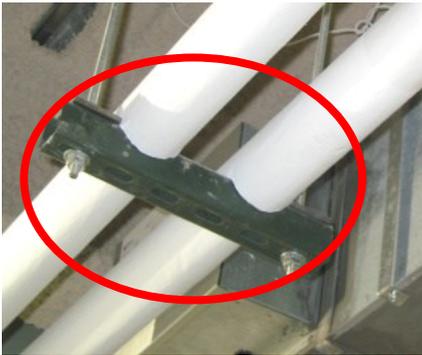
Sometimes, things just get in the way and are cut out by one trade with no regard for another.

The vapor barrier integrity is critical from keeping water from dripping on ceiling tile and supporting the creation of mold.

1. Review vapor barrier installation once the installation is complete. Make sure all the joints are properly taped and any holes sealed.
2. Notify all trades that, as they work around newly installed vapor barrier, they need to be careful and make sure Pepper's superintendent is aware of ANY damage noticed or caused during their work.
3. Mark any vapor barrier breaches in green or red in order for future identification prior to any ceiling or wall installation.
4. Review the vapor barrier installation one more times after secondary trades have been in the area and **prior** to any ceiling or wall installation.
