Gypsum board sheathing damage MUST be repaired (replaced) STUD to STUD prior to any roofing or air /vapor barrier being installed:

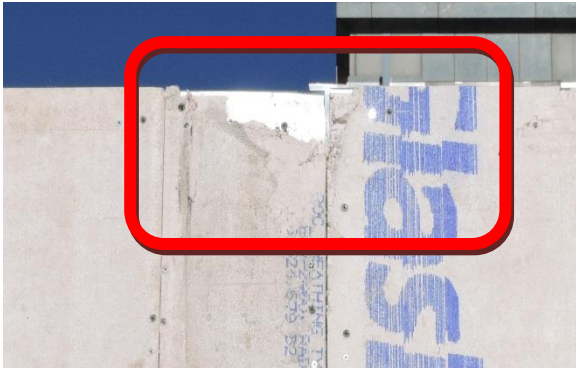
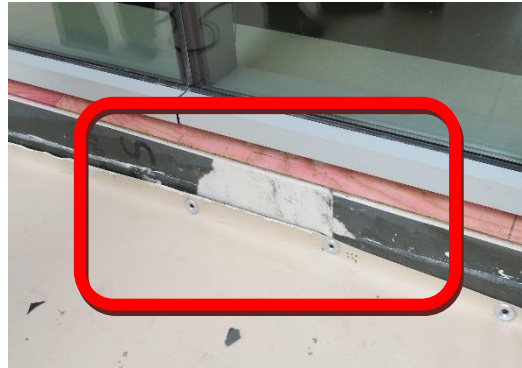
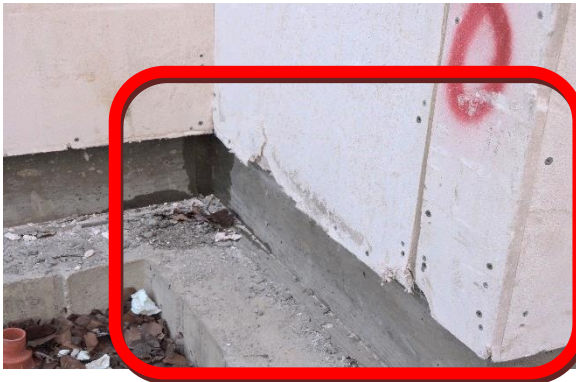
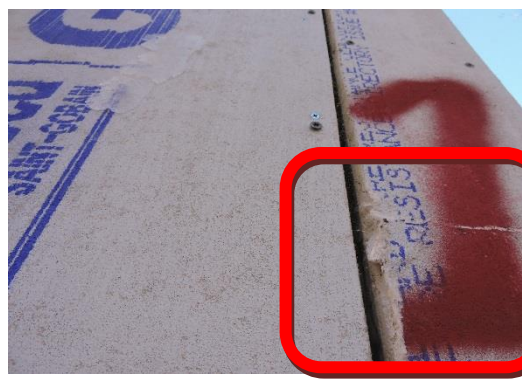
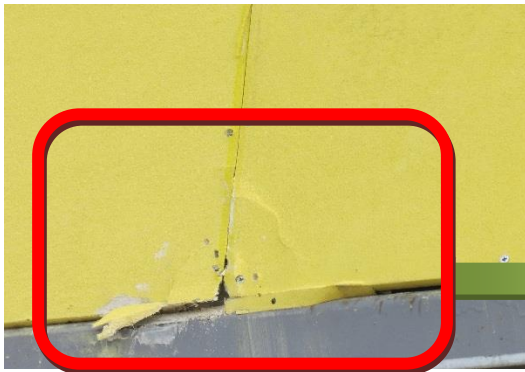
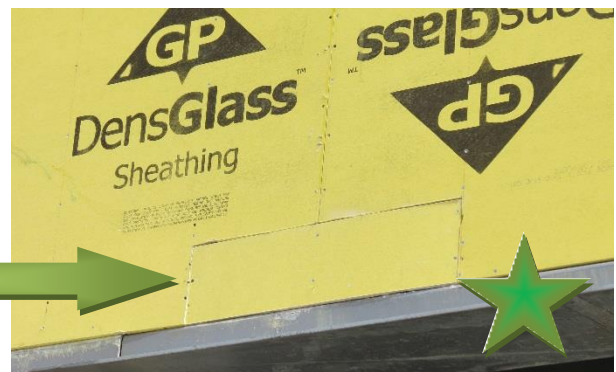
When the paper face is torn off, the roof adhesive or the air/vapor barrier will get sucked into the gypsum and not properly adhere.

The roofing & air/vapor barrier needs to be fully supported. Damaged sheathing or sheathing that the face material has been torn off is not proper support for the roofing or air/vapor barrier – this will cause failure.

Always review your sheathing prior to the installation of the roof or air/vapor barrier & always repair stud to stud.
